Manhole Inspection Summary

Manhole # S13EE2012MH

Location Address: **2114 WESTERN RUN DR**

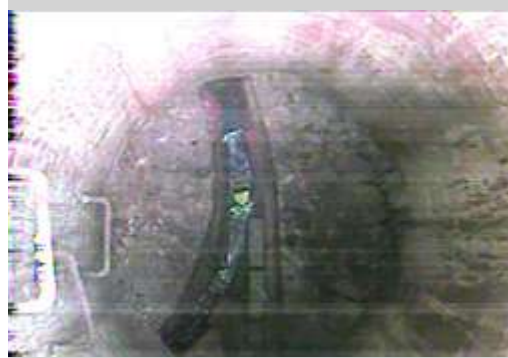
Top View

Bench debris.

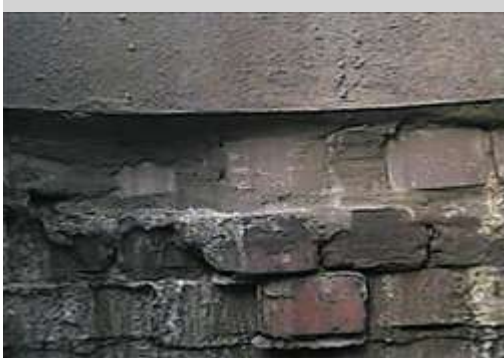
Defect

☒ **Leaks**

Condition: ☐ Sound ☐ Cracked ☐ Root Intrusion ☐ Loose Brick ☒ **Deteriorated**

Infiltration: ☐ None ☒ **Joint** ☐ Cracks ☒ **Mortar** ☐ Roots ☐ Wall

Frame leaks. Adjustment deterioration and infiltration.

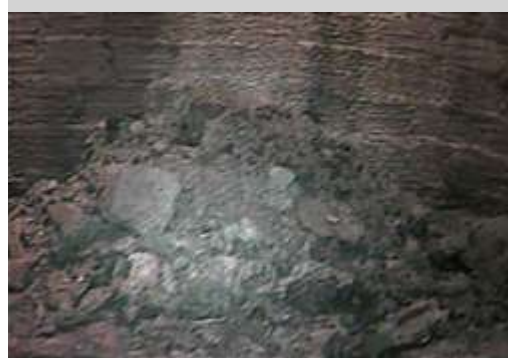
Defect

☒ **Debris** (not Condition related)

Bench debris.

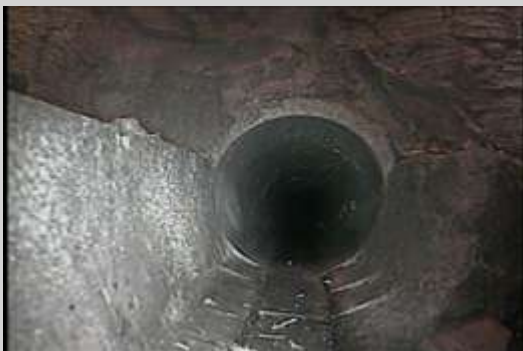
8 in. Circular Gravity Sewer Pipe In @ 6 O'Clock

Infiltration: **Evidence** Pipe Seal Cond: **Cracked**
